Northfield Foundry & Machine Co., Inc.

MODEL 240 FACER-PLANER "TECH TIPS" #2

March 1997

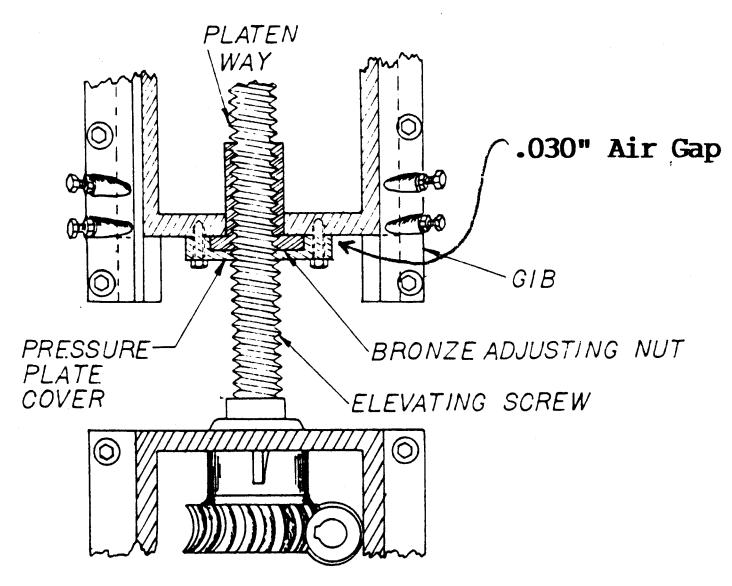
TOP PLATEN ALIGNMENT
PLATEN ELEVATING SCREW and NUT

If you have been replacing Part No. 240-354, Brass Elevating Nut, frequently, the problem may be with the 240-355 Pressure Plate Covers.

The pressure plate covers are the steel cups that clamp the brass elevating nuts to the bottoms of the cast-iron leg columns after the upper platen has been leveled.

When the steel cups are drawn up tight against the brass nut flange, there should be at least a .030" (1/32") air gap between the steel cup and the leg column. If the cup draws up tight to the bottom of the leg, the brass nut can spin inside the steel cup, losing all your platen alignments. This eventually results in so much pressure building up that the threads tear out of the brass nut.

To correct this, you can check for air gap with a feeler gauge, and the cups that are not clamping properly can be taken to a lathe to machine the top of the cup to provide proper air gap clearance.
